# The wreck of the *Jenny Lind*

## THE KENN REEFS ARCHAEOLOGICAL SURVEY

Maritime archaeologists affiliated with the Australian National Maritime Museum and Silentworld Foundation recently led an expedition to the Australian Coral Sea Territory to conduct an archaeological survey of historic shipwrecks lost at Kenn Reefs during the 19th century. **James Hunter and Renee Malliaros** report on their findings.

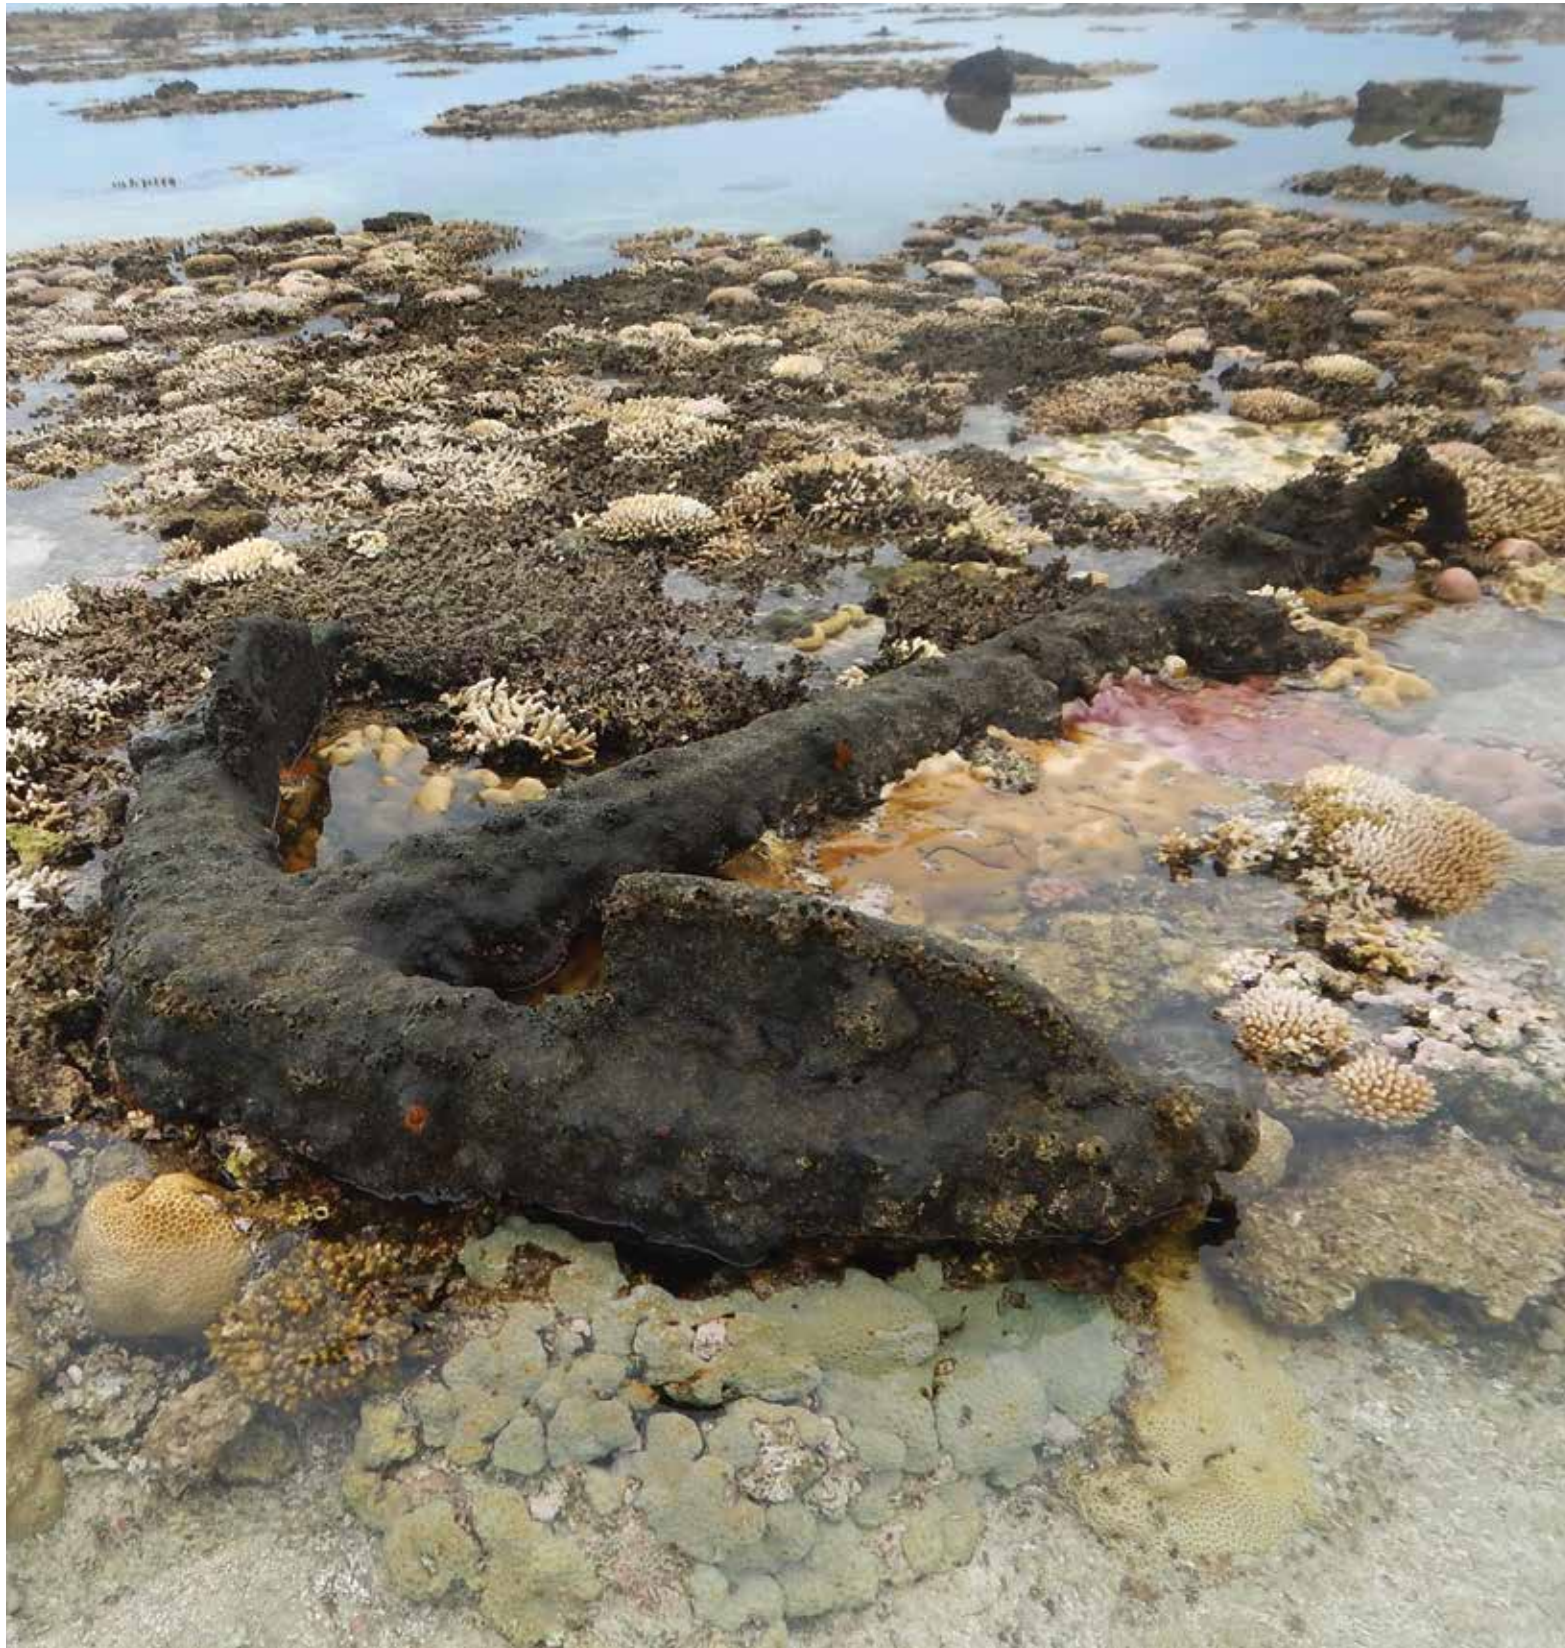
01 A single Admiralty pattern anchor is located on the reef top close to the mound of iron bar stock. It is of British manufacture and its dimensions indicate it would have been used as *Jenny Lind*'s stream anchor. Image Renee Malliaros/Silentworld Foundation.

Located around the mound are other artefacts and features, including stud-link anchor chain, several large unidentified concreted iron objects, windlass components, a small number of indeterminate iron structural elements, and an Admiralty pattern anchor. The anchor was relocated and inspected during the 2017 survey, and its position plotted with Global Positioning System (GPS). Its shank is 2.9 metres long and the distance between the 'bills' (the protruding tip of each 'palm' or fluke) is 2.0 metres. A 'key' near the top of the anchor's shank indicates it would have been fitted with a wooden stock, but given that the anchor is lying flat on the reef top and not 'picked in', it may not have been used when the wreck occurred. The anchor is clearly of British design and manufacture, as its protruding bills are a distinct attribute of Admiralty pattern anchors. Given *Jenny Lind*'s origins and subsequent British use, the presence of a British-manufactured Admiralty pattern anchor at the shipwreck site offers additional evidence of its identity as the Canadian-built barque.

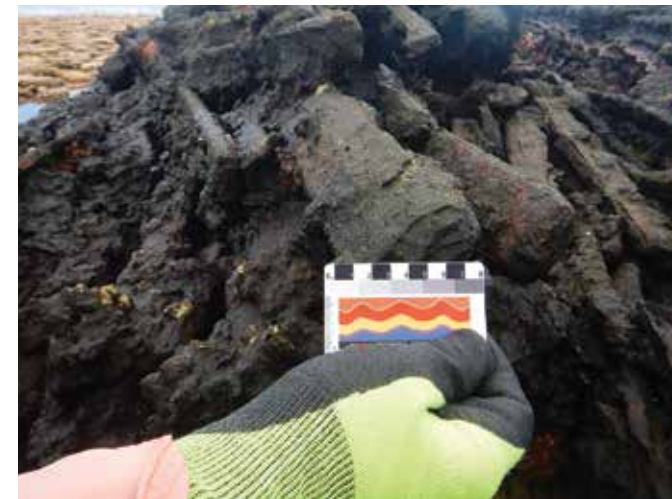
- 01 Detail of some of the concreted wrought iron bar stock that makes up the majority of the mound.
  - 02 This iron 'key' located near the top of the anchor shank indicates the anchor would have been fitted with a wooden stock.
  - 03 Concreted remnants of an iron windlass pawl located on the *Jenny Lind* site. Its diameter measures 62 centimetres.
- All images Renee Malliaros/Silentworld Foundation

Inspection of the bar stock during the 2017 survey revealed it was manufactured from wrought iron, widely used during the 19th century because it was both tough and malleable. These qualities meant it could be easily worked into a variety of products, including structural elements for ships and buildings. Architectural components manufactured from iron were often loaded aboard ships as cargo, but because of their great weight also functioned as ballast. In the case of *Jenny Lind*, archival sources do not specifically state the vessel was carrying a cargo of iron. Indeed, most accounts state it was only loaded with a 'small quantity of flour and beef',

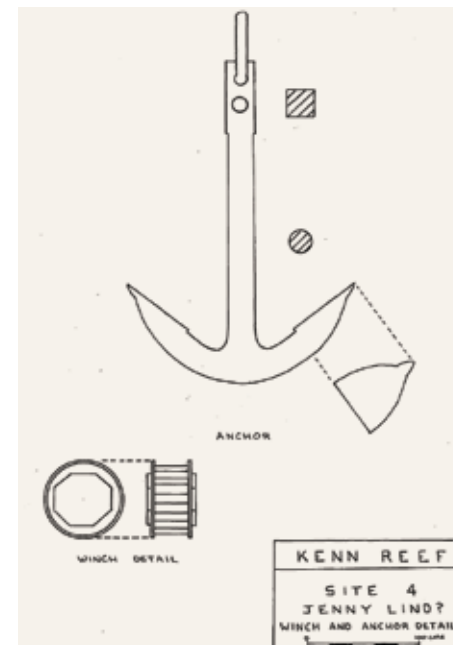
- 01 A modern satellite image showing the location of the *Jenny Lind* shipwreck site (highlighted by red rectangle) relative to Observatory Cay. Digital Globe Imagery/Silentworld Foundation
- 02 The mound of iron bar stock and ballast that forms the centrepiece of the *Jenny Lind* shipwreck site. About 1.5 metres high, it consists primarily of iron bar stock and rods lying atop stone ballast. Renee Malliaros/Silentworld Foundation
- 03 A scale drawing of *Jenny Lind*'s anchor and an anchor windlass component located nearby, as documented in 1987. Warren Delaney/Queensland Department of Environment and Heritage Protection
